## Evaluation of heritage building rehabilitation in Egypt : The case study on Wakala Al-Ghouri

Review  
Article

Fatma Magdy Zidan, Ayman Abdel-Tawab, Wesam Abou Elhaggag Mehanna

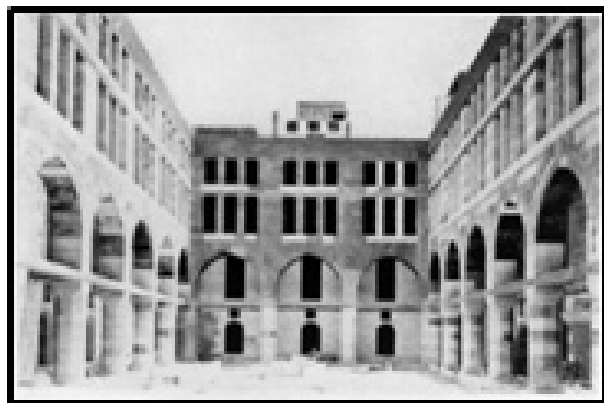
1. The wakala went through a lot of changes, the first of which was by the Authority for the Preservation of Islamic and Arab Antiquities in 1882 AD, when a plan was submitted to control and confiscate the wakala, and nothing remained of the documents except for the wakala's photographs taken in 1909 AD, which recorded its condition at the time. However, there is a difference between its image and the current reality, but many of its architectural details remain<sup>[20]</sup>.

Fig. 2: Front facade of the inner courtyard during the initial restoration process<sup>[29]</sup>.

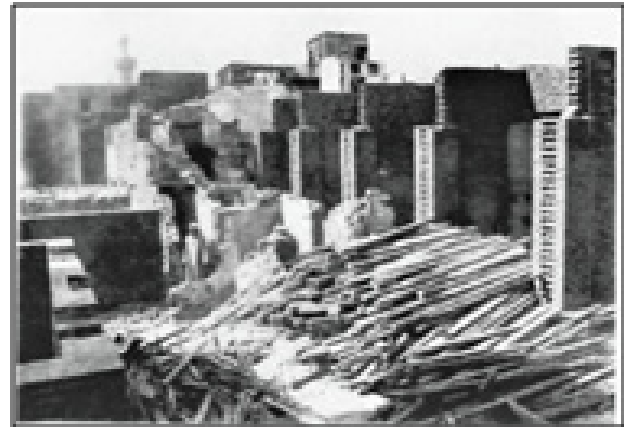
2. The wakala was restored and renovated in 1346 AH - 1926 AD, and the date was found on a stone in the inner facade of the entrance, while the dilapidated parts were built on the upper floors in the residential part with red bricks and the ceilings were placed complete with concrete ceilings that still exist until now, with the creation of An internal wooden staircase connects the first floor to the upper floor instead of going up through a separate external door<sup>[29]</sup>.

Fig. 3: Front facade of the inner courtyard during the initial restoration process<sup>[29]</sup>.

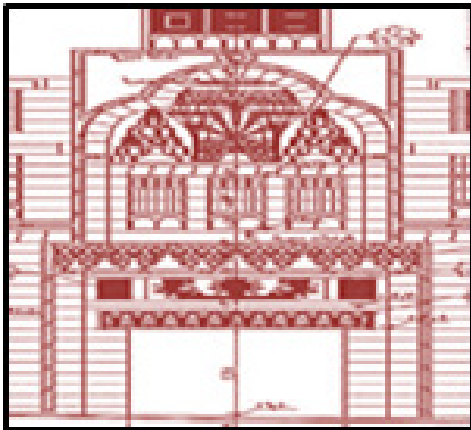
The wakala has three entrances, first the main entrance: it is located in the middle of the main facade, and it is two floors high with an arch at the end of the muqarnas. Wooden door topped by an ornate lintel<sup>[1]</sup>. Secondly, the first sub-entrance: It is the entrance to the tannery, which is in the main facade on the left. It is made of wood on a long vestibule covered with a long vault, to which eight doors open, and each door leads to an entrance with a vaulted ceiling<sup>[43]</sup>. Finally, the second sub-entrance: this entrance is located at the far-left end and has stairs to access the upper floors, which are designated for accommodation to provide privacy. It is a rectangular wooden door<sup>[15]</sup>.

Fig. 4: The main entrance of wakala<sup>[24]</sup>.

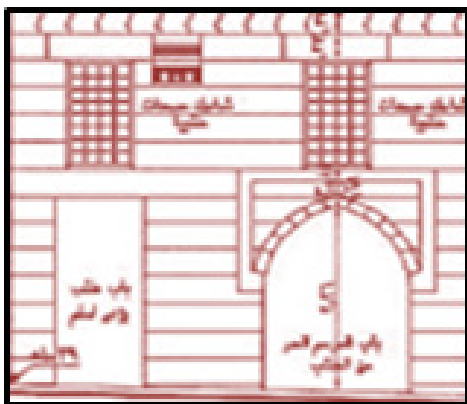
Fig. 5: The first and second sub-entrance<sup>[24]</sup>.

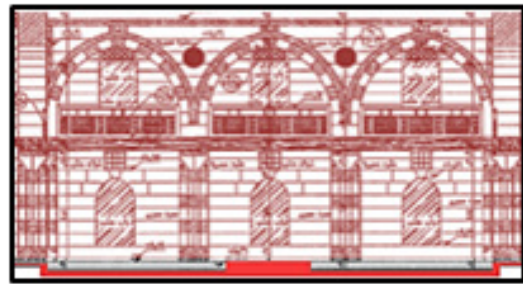
All housing units on the upper floors overlook the inner courtyard, which confirms the principle of openness to the interior as the source of ventilation for crops and housing units<sup>[22]</sup>.

Fig. 6: Section in the Courtyard of Wakala Al-Ghuri<sup>[24]</sup>.

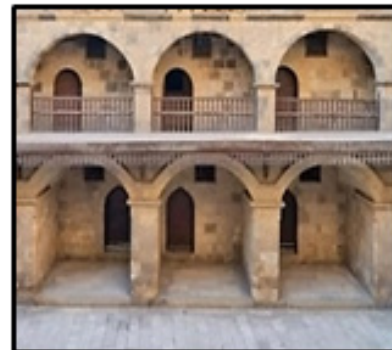
It is covered with a semi-circular stone vault to lighten the loads on the foundations, and it differed in the interior spaces. In the spaces overlooking the main facade, there were windows on the facade and another above the door. But the internal crops had only one window above the door, and it was used for lighting and ventilation<sup>[42]</sup>.

Fig. 7: Clarification of store vaults<sup>[12]</sup>.

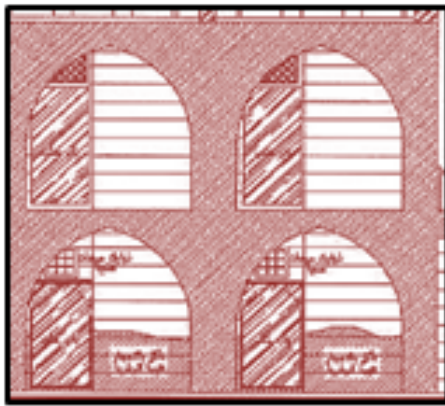
Fig. 8: A section in the basement warehouses from the inside<sup>[24]</sup>.

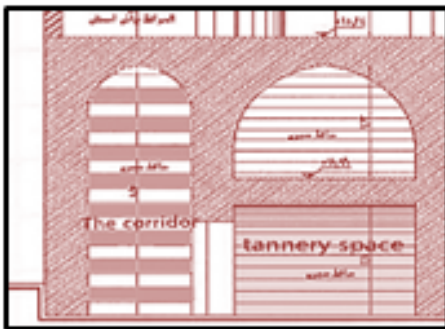
It is a place where the yarns are dyed attached to the wakala. It has housing units for its workers. It is accessed from the first sub-entrance. It consists of eight rooms overlooking a small courtyard that was used to dry the yarns<sup>[43]</sup>.

Fig. 9: A section in the tannery<sup>[24]</sup>.

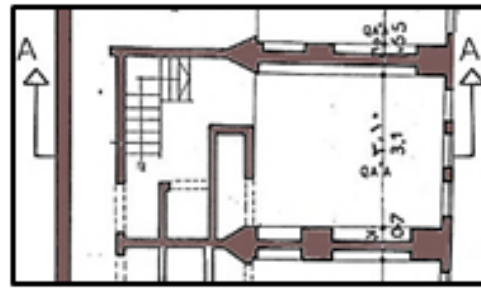
The residential rooms provide the privacy of the merchant, with the presence of wooden mashrabiya with small openings on the third level, while the windows on the first level are large openings and solid wooden covers that open upwards to allow the merchants to see the plate, and the second level the openings are grilles made of wood and do not open and help in entering a large amount of lighting<sup>[33]</sup>.

Fig. 10: Plan of the ground floor in the residential unit<sup>[24]</sup>.

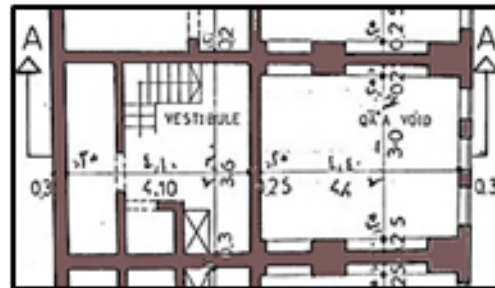
Fig. 11: Plan of the first floor in the residential unit<sup>[24]</sup>.

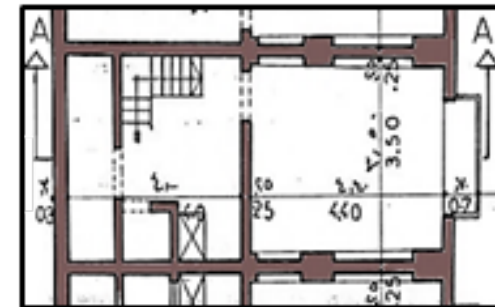
Fig. 12: Plan of the second floor in the residential unit<sup>[24]</sup>.

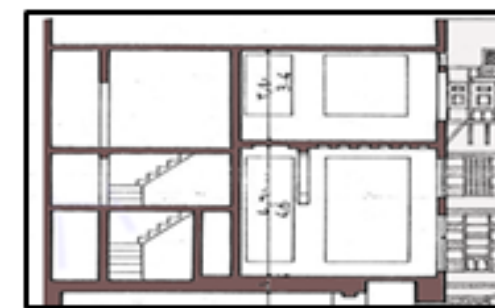
Fig. 13: Section of the residential unit<sup>[24]</sup>.

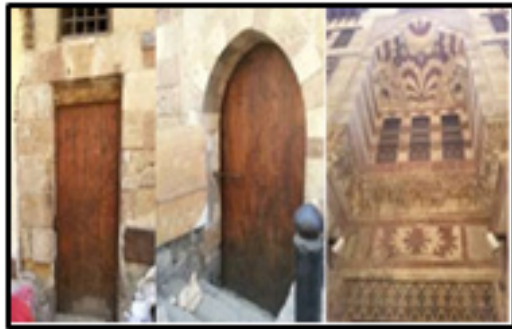
1. Treating facade cracks by strengthening and providing treated wood against rotting and decomposition across the entire width of the wall and filling the facade cornices thoroughly with lime mortar, the threshold is cleaned and the spaces between the units are well filled with a cured cement mortar. The door wood is cleaned and

painted against damage and moisture, damaged parts are restored, and the necessary hardware is installed.

Fig. 14: Clarification of the three entrances to Wakala Al-Ghouri<sup>[43]</sup>.

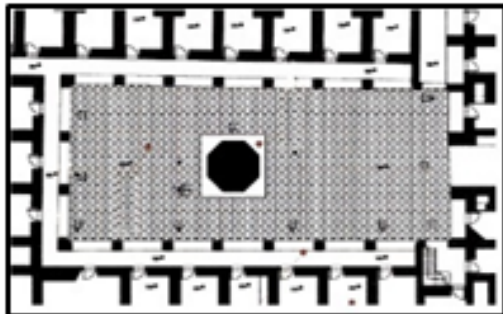
2. Treatment of moisture and salts in the walls, remove dilapidated floors and add new floors of the same type. Filling cracks with cement-lime mortar containing additives to prevent shrinkage, strengthening them, and furnishing them with rot-treated wood over the entire width of the wall are all ways to treat cracks.

Fig. 15: The Courtyard of Wakala Al-Ghouri<sup>[24]</sup>.

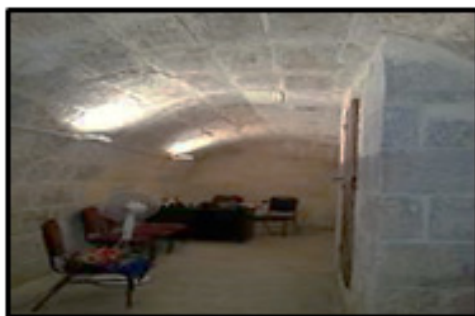
3. Re-use the ground floor as stores for ceramic works and other spaces used as a permanent exhibition of traditional and plastic arts, the residence of cleaners, the headquarters and celebrations of the Asala Association, carpentry workshops and toilets, and the reuse of the first floor is administrative offices, computer room, stores, the office of the security supervisor, the protocol department, the general supervisor and the association Arts and Artistic Perspective and the National Society of Fine Arts<sup>[7]</sup>.

Fig. 16. The basement warehouses from the inside<sup>[43]</sup>.

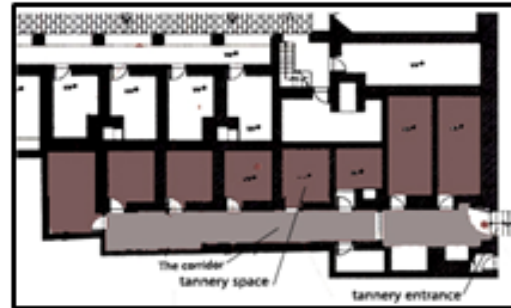
4. The tannery has become the property of the Al-Asala Association to display its products, sponsoring traditional crafts and arts that have disappeared or are on the verge of extinction, as it includes at least 20 traditional crafts<sup>[40]</sup>.

Fig. 17: The plan of the tannery<sup>[24]</sup>.

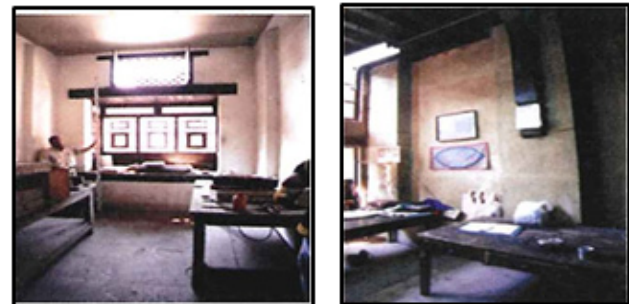
5. The wooden ceilings of the unit were restored, the walls were treated against the base, the salts were removed, the missing parts were completed, and the floors were maintained<sup>[43]</sup>. The Ministry of Culture rents out housing units for artists, which has led to the rooms being turned into private property for them, and the Ministry of Antiquities has no possibility of supervising them<sup>[35]</sup>. Repairing fractures and strengthening them, replacing damaged bricks with new flooring made of the same material. Salts and dampness have been removed from internal and external walls.

Fig. 18: The inside of residential rooms<sup>[13]</sup>.

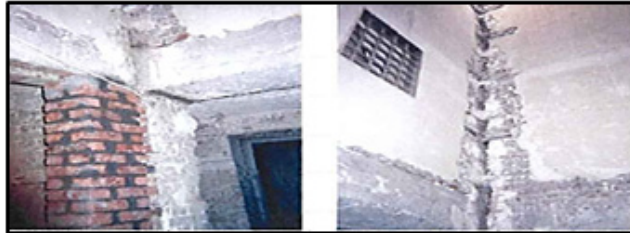
There is a crack in the wall of wakala that goes through

the residential part that was reconstructed in the initial restoration process, so it was treated by filling it with sheets of foam and then painting it with polysulfide after cleaning. And the part of the entrance, which represents a structural hazard, was installed during the restoration with a steel pillar, the dilapidated shoulder was demolished and a new one was built of red bricks<sup>[20]</sup>.

Fig. 19: Clarification of the crack in the entrance wall and the new brick shoulder<sup>[13]</sup>.

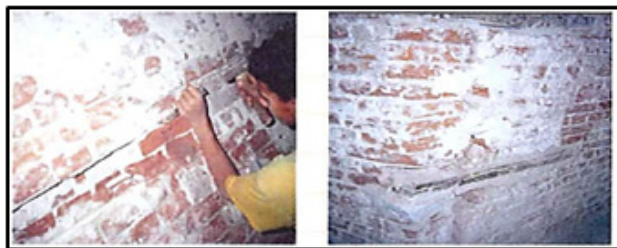
The narrow and capillary cracks are cleaned with compressed air, sprayed with water, and filled with lime mortar to a depth of 5 cm. According to the instructional studies, deep cracks are restored using a double of completely dry hardwood, its sector 4 \* 4, with a length of not less than a meter, and it is treated against decay, moisture, and insects<sup>[20]</sup>.

Fig. 20: Narrow, and deep crack after restoration<sup>[13]</sup>.

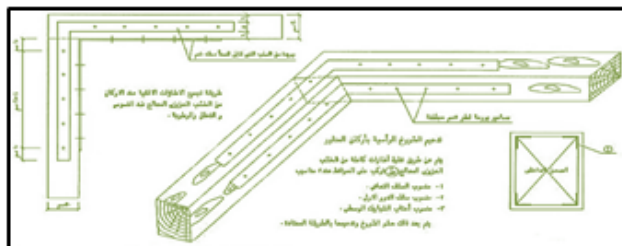
Strengthening walls in skylights and corners, treating cracks, internal and external facades, and studying how to connect walls in corners<sup>[20]</sup>.

Fig. 21: Strengthening walls and corners<sup>[13]</sup>.

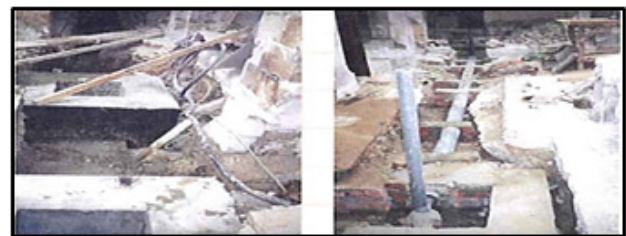
The toilets in the residential units are maintained and a new drainage network was made it was found to be deteriorated, so the plan that was implemented was: dismantling the devices and floors, making a method of insulation in the entire bathroom, covering the floor, and installing the feeding and drainage connections for the basin only, without installing the toilet<sup>[15]</sup>.

Fig. 22: The toilets in the residential units<sup>[13]</sup>.

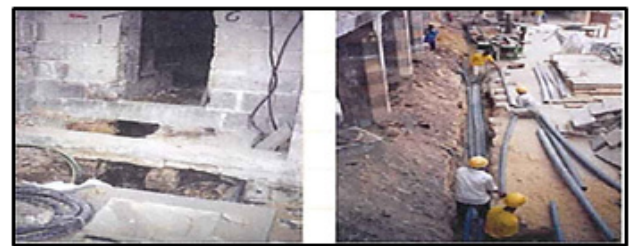
Designing new electrical distribution panels and installing them in places according to the distribution of loads in the network, removing high electrical connections, current switches, and sockets, designing electrical connections network from PVC plastic pipes, using a buried electrical network, and choosing a cover for sockets, switches, and connections from fiber that matches the color of the stone<sup>[5]</sup>.

Fig. 23: New electrical distribution and installation<sup>[13]</sup>.

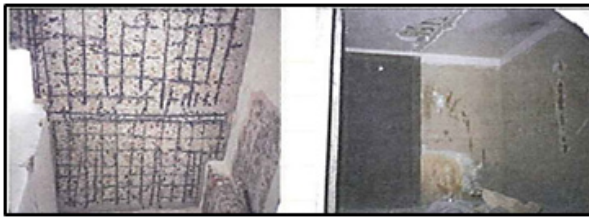
Repairing the dilapidated reinforced concrete in the ceiling, as the iron in it is irregular and the rebars are corroded and the white parts are falling off. It is restored by removing the layer of whiteness, and the concrete cover, then sanding the existing iron, then building and adding iron according to the construction drawings<sup>[20]</sup>.

Fig. 24: Reinforcing decayed concrete<sup>[13]</sup>.

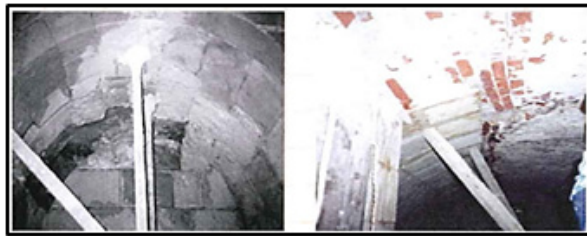
The vaults were restored and strengthened, salts and sediments were removed from them, isolated, and re-painted again using supporting pillars<sup>[20]</sup>.

Fig. 25: Clarification of vault repair<sup>[13]</sup>.

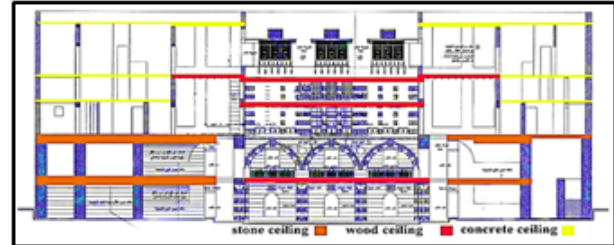
The ancient wooden ceilings that still exist in some housing units on the second floor were restored and repainted, and the stone and concrete ceilings were restored after rebuilding them in the first restoration phase<sup>[20]</sup>.

Fig. 26: An explanation of the different types of ceilings after the restoration process<sup>[13]</sup>.

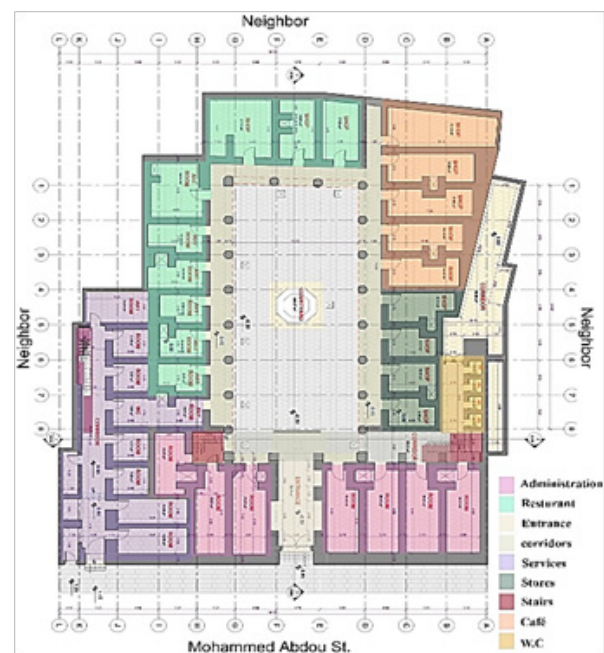
The following is a suggestion from the researcher for the ground and first floors to reuse the wakala as a heritage hotel:

Fig. 27: Plan of reusing the wakala's ground floor as a heritage hotel<sup>[24]</sup>.

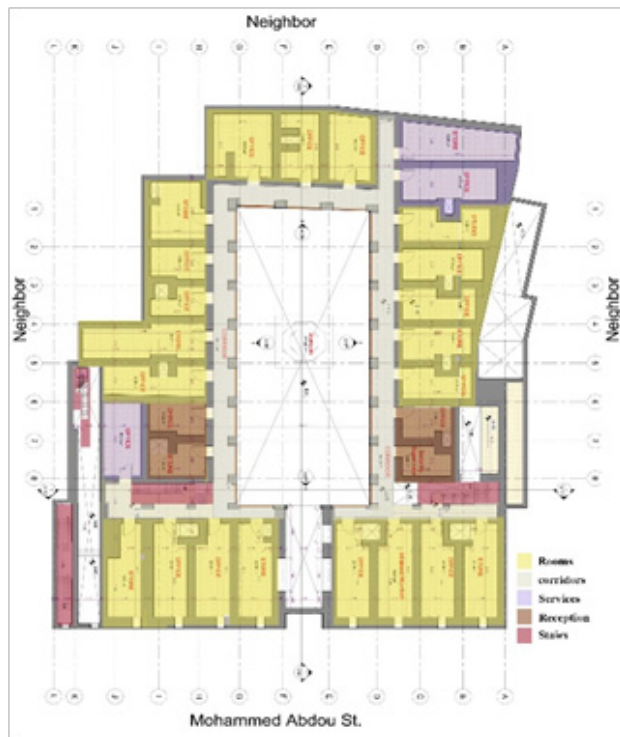
Fig. 28: The plan of reusing the wakala's first floor as a heritage hotel<sup>[24]</sup>.
